Fair Wear & Tear Guideline for Vans

GUIDELINE

Acceptable and unacceptable damages

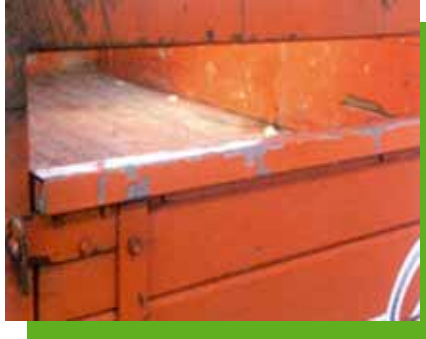
Dents or bumps in the partition walls being caused by transportation of goods or loading without infringing on the function of the loading or passenger compartment.

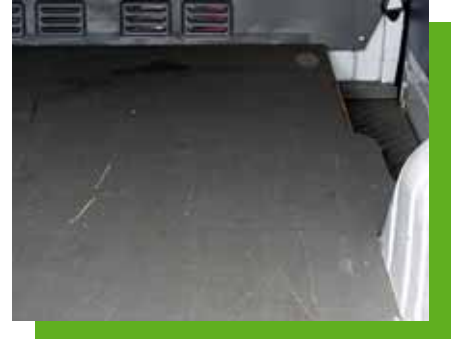
Abrasions on the sills of the loading compartment or walls due to normal loading activities.

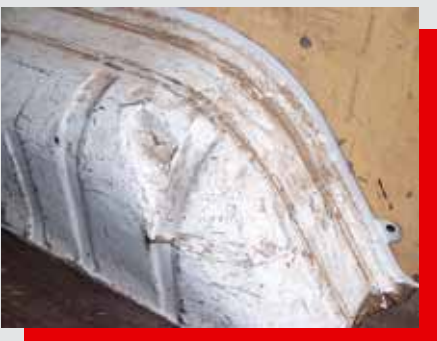
Heavy deformations of the wheel casing and signs of improper loading or insufficient securing of loaded goods.

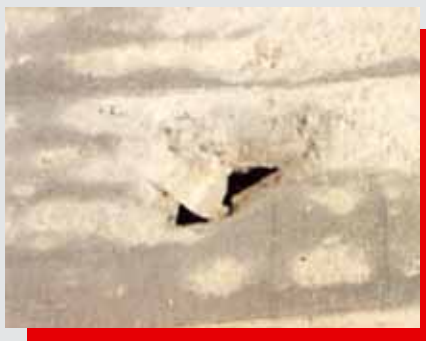
Holes in the loading floor or in body parts. Damaged, dented or broken interior lining ...

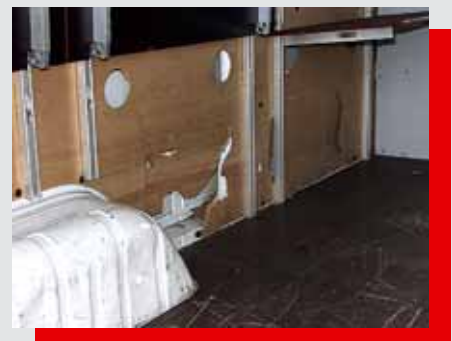
... limiting the use of doors, windows or fittings.

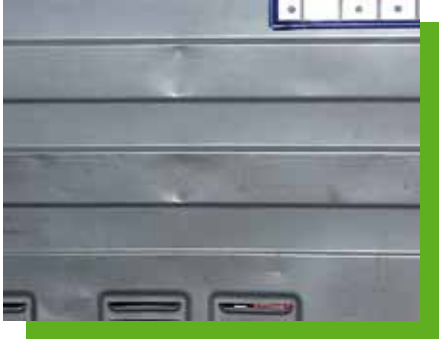
Abrasions, scuffing and scratches on the loading floor caused by transportation of goods or loading activities.

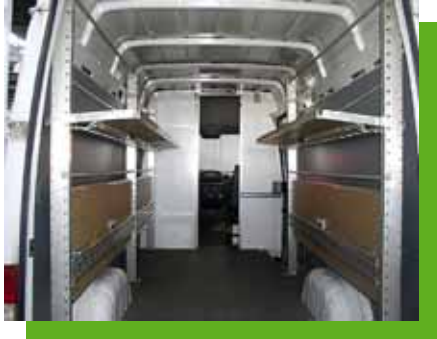
Additional fittings remaining in the vehicle as long as they are properly built-in and comply with the regulations for the vehicle.

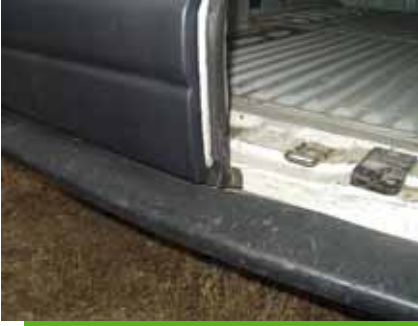
Scuffing and scratches or abrasions on sills of loading compartments or bumpers in that area.

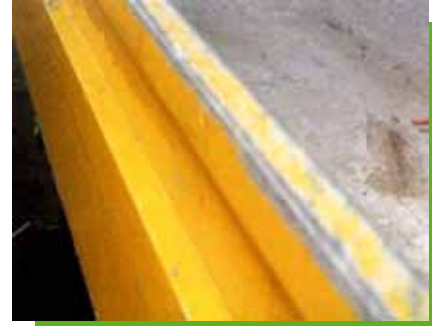
Abrasions on the sills of back or sides doors of the loading compartment caused by loading of goods.

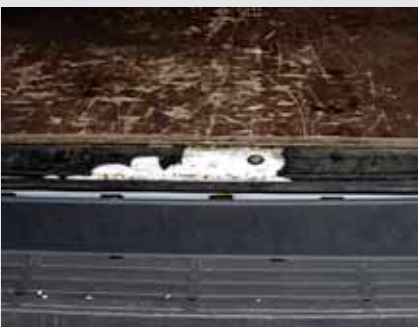
Rips or tears or missing parts on the loading floor or lining in the area of the loading compartment.

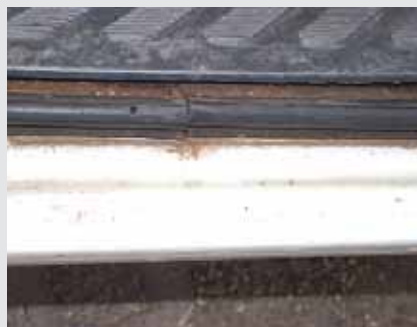
Damages to body parts or paint in the area of the loading compartment causing rust.

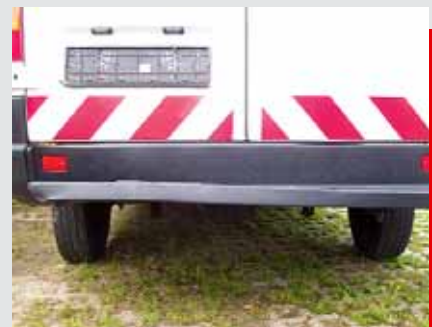
Damages from impacts in the area of the loading compartment. Deformed sills or broken material of the sills.

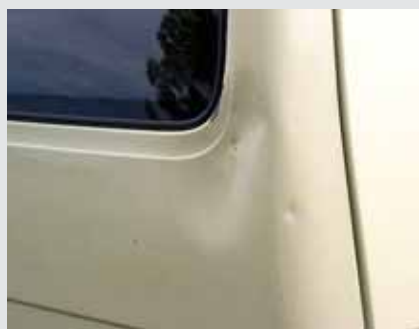
... with or without damages to the paint with a diameter of more than 20 mm = size of the 1 Euro coin.

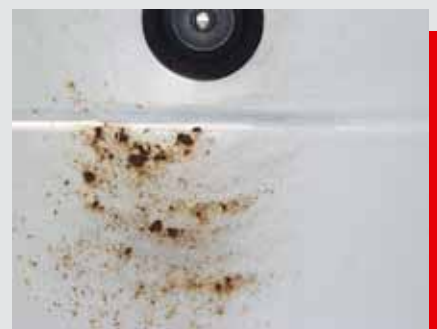
Damages to the paint through to the metal and/or having caused rust.

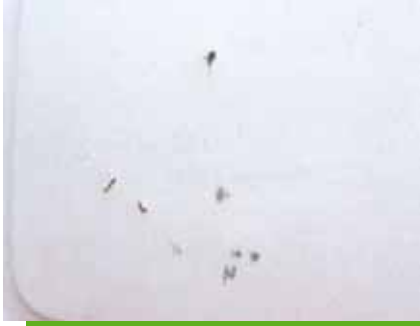
Damages in paint not through to basic material.

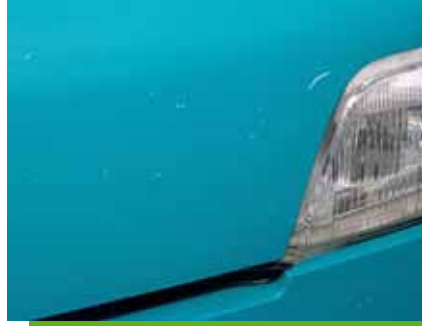
Scuffing or scratches with a maximum length of 100 mm.

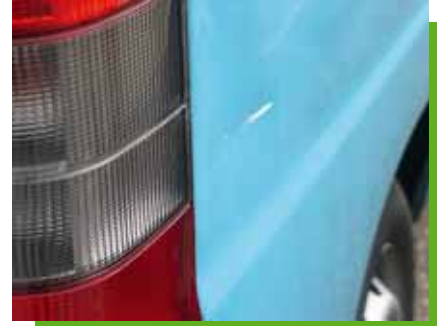
Scuffing or scratches even with damages to the paint, if the diameter does not exceed 20 mm each (size of the 1 Euro coin).

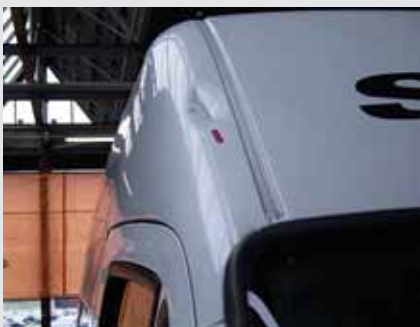
Deformation of the vehicle body with or without damages to the paint with a diameter of more than 20 mm each (size of the 1 Euro coin).

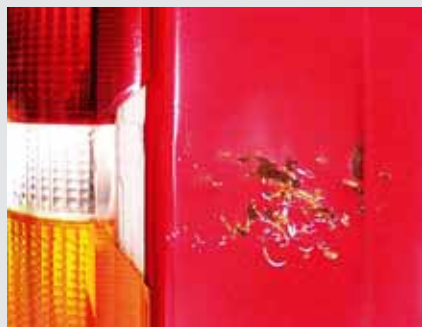
Scuffing and scratches through to the metal or substantially influencing the optical condition of the vehicle by their number on one body part.

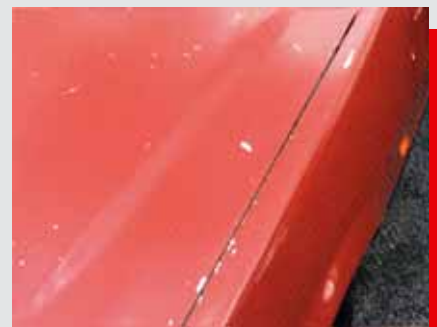
Scuffing and scratches through to the metal or more than two scratches on one body part.

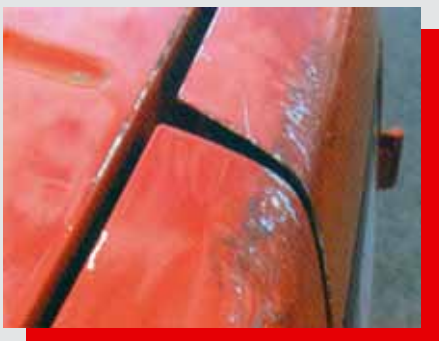
Scratches, paint damage or abrasion on body parts, which do not belong to the normal area of loading. Paint damage on Roof sills caused by improper loading on and off roof racks.

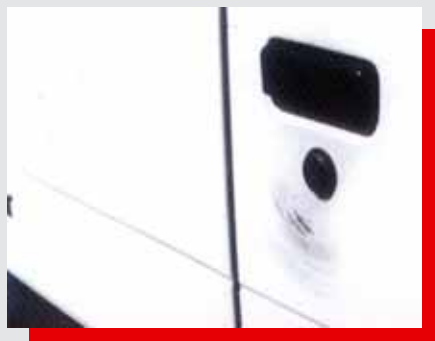
Scuffing and scratches influencing the optical condition of the vehicle by their number on one body part.

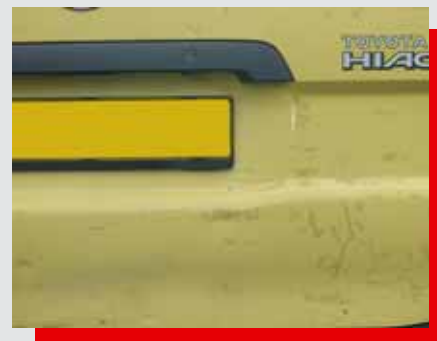
Accumulation of bumps, dents or scratches on body parts e.g. doors or hoods caused by impact when opened or improper secured loads on the roof.

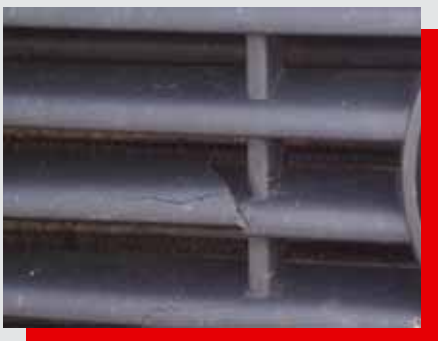
Grille broken by impact of chipping.

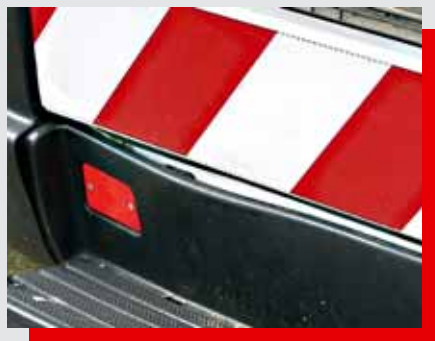
Bumper or sills showing deformations or tears.

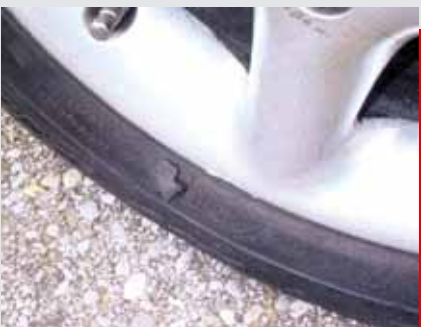
Tyre with damage caused by impact known to happen through 'kerbing'.

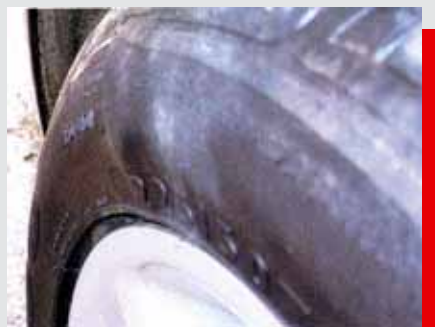
Clearly visible dents caused by breaks in the sidewalls of the tyre or missing material.

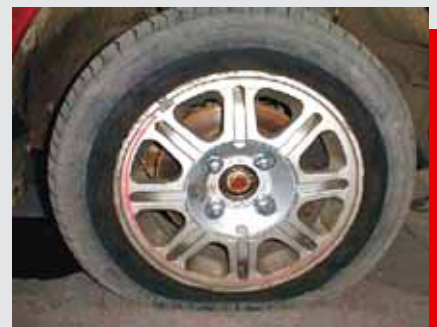
Tyres with inappropriate air pressure inconsiderable whether caused by damage or penetration of foreign particle. All damages influencing the vehicle safety.

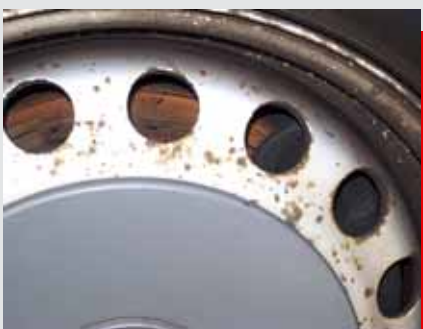
Deformation of the bead of the rim, missing material or rust.

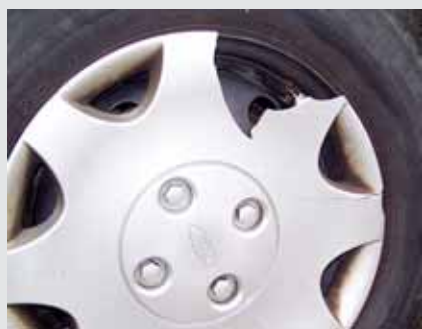
Breaks or missing material on wheel caps. Scuffing and scratches causing a deformation of the wheel cap.

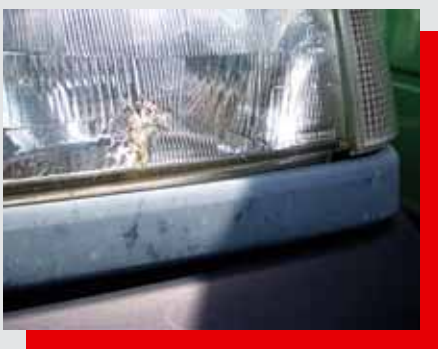
Chippings in the headlights, fog lights or indicators having broken the glass or the transparent covers.

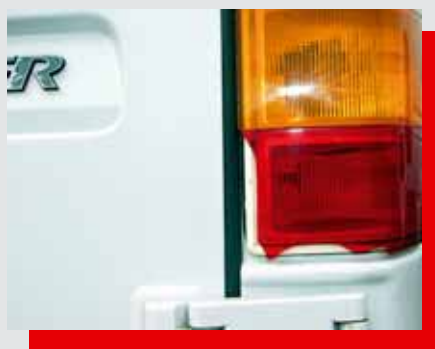
As before: The damages show as a tear or a hole and influence the technical function.

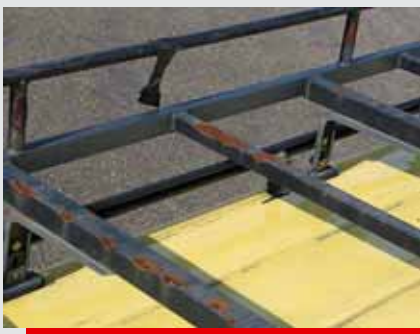
Fitted roof racks must not be broken and must be fitted correctly. The rack must not be influenced in its safety by rusted material.

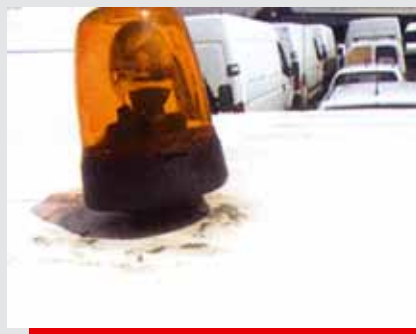
Fitted beacons or lights showing breaks in the glass or not fitted correctly. These lights do not comply with the legal requirements for road safety or are influenced in their function.

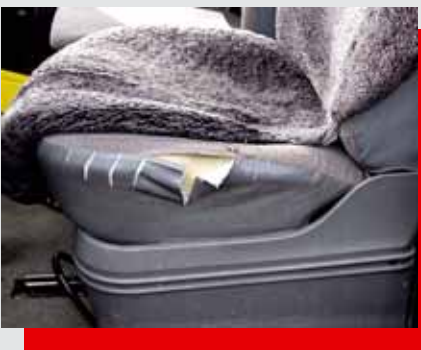
The seats covers are torn or material is missing from the upholstery.

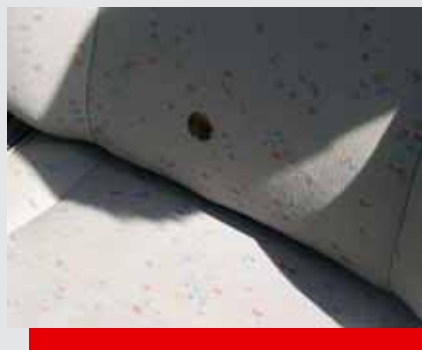
The upholstery is burned or cut. The use is influenced through clearly distinctive smells.

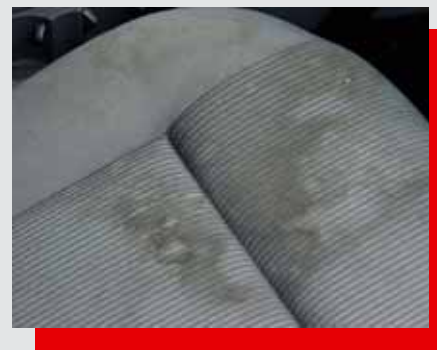
The seats are heavily stained. The staining is not only on the surface and cannot be removed by normal cleaning.

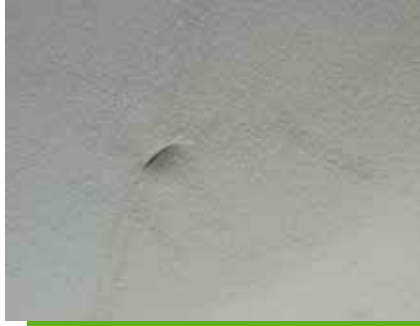
The headlining of the driver's cabin shows minor damage, but is not influenced in its function.

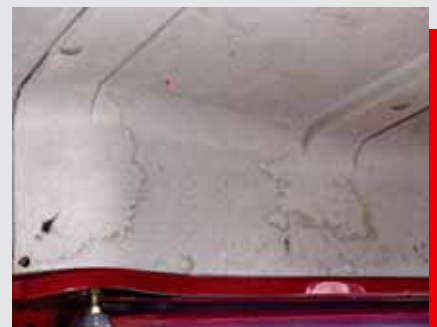
Panel headlinings are deformed or show cuts in material or are heavily stained.

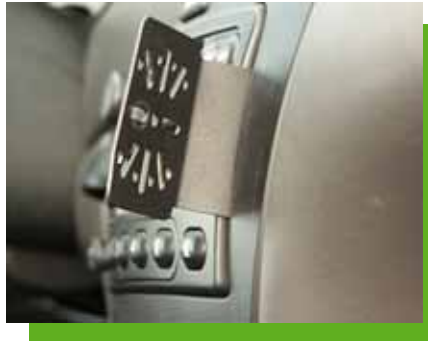
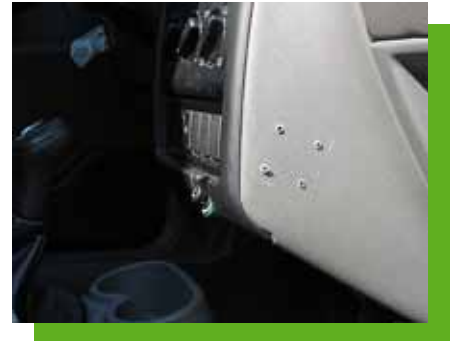
Handles of additionally build-in accessories remained in the vehicle. Telephones or handles have been deinstalled, ...

... and the holes are either invisible or in the sides of the middle console.

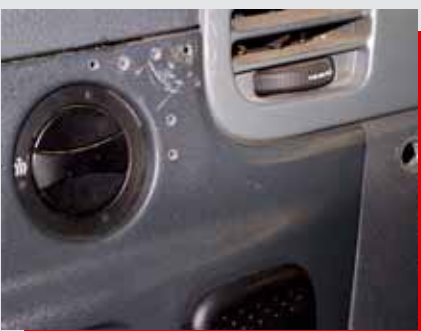
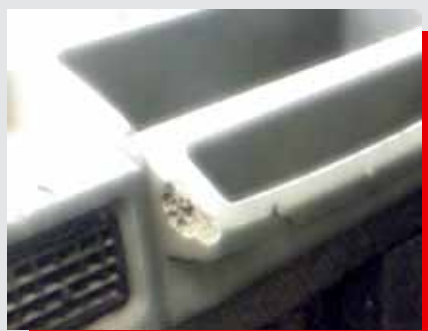
Handles for accessories, telephones or telephone handles have been deinstalled. The holes are clearly visible in the driver or passenger area.

The dashboard is visibly damaged and the surface material is damaged or material is torn out.

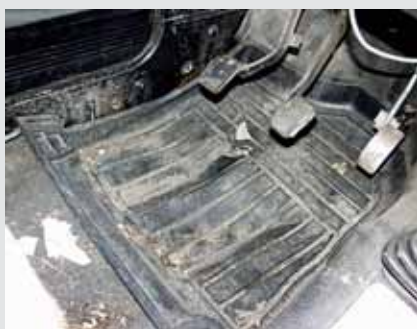
The vehicle carpet shows clear tears, holes or visible stains and dirt marks.

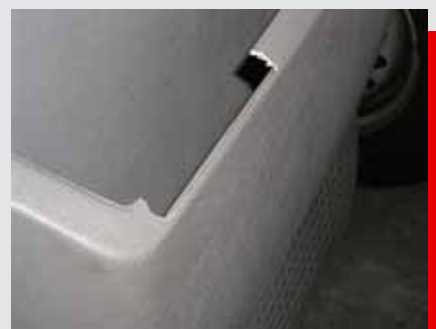
Storage areas in the doors or at the dashboard are torn or material is broken.
