Fair Wear & Tear

Guidelines for Vans

Accepted by leading European leasing companies

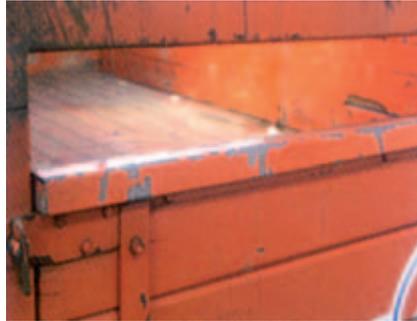
General dents/bumps in the walls of the loading area, caused by loading of goods, providing this does not interfere with the function of the compartment.

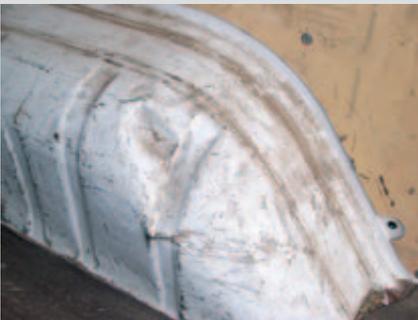
Heavy deformations of the wheel casing and signs of improper loading or insufficient securing of loaded goods.

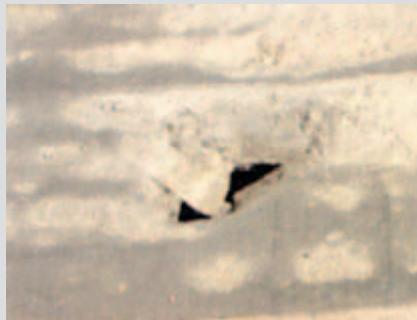
Holes in the loading floor or severe deformation due to improper loading.

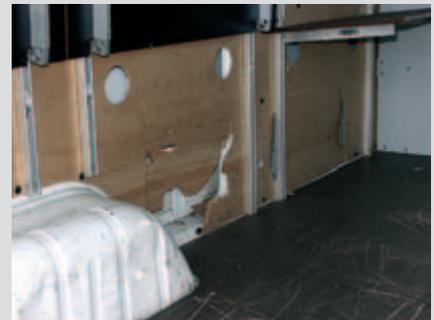
Damaged, dented or broken interior lining limiting the use of doors, windows or fitting.

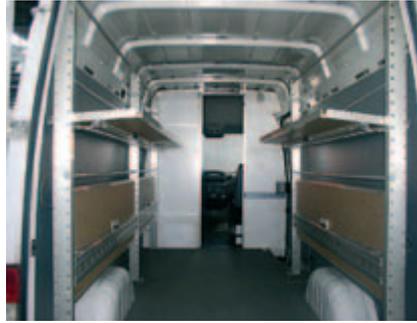
Additional fittings left in the vehicle, provided they are properly built-in and comply with the regulations for the vehicle.

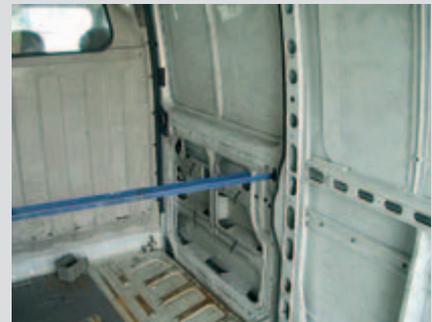
Missing interior linings & partition walls are not acceptable. Temporary “fixes”, as demonstrated above, should be made good. It is not acceptable for the vehicle to be returned in this condition.

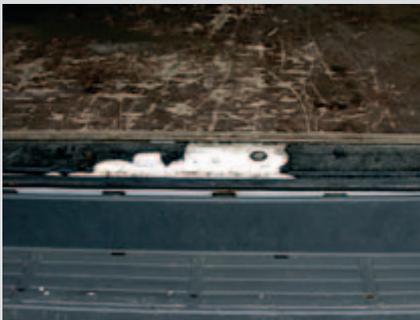
Rips, tears or missing parts on the loading floor or lining in the area of the loading compartment.

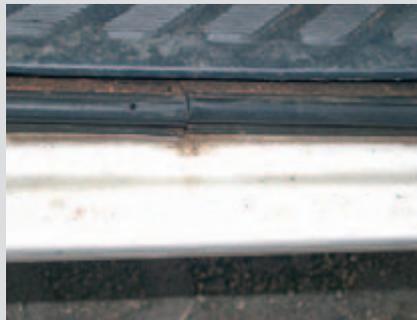
Excess damage in the loading area causing deformation or rust.

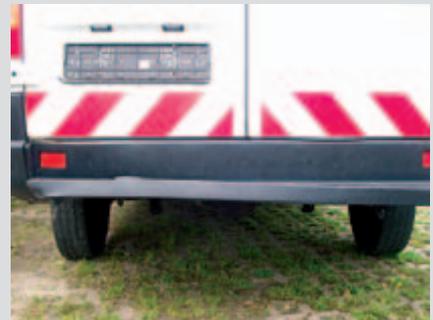
Damage which has deformed the sill.

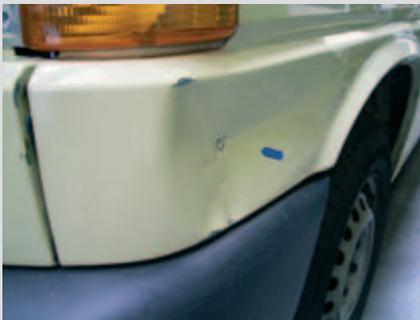
Bumps, dents or deformation of the vehicle body where the diameter of the damage exceeds 20mm ...

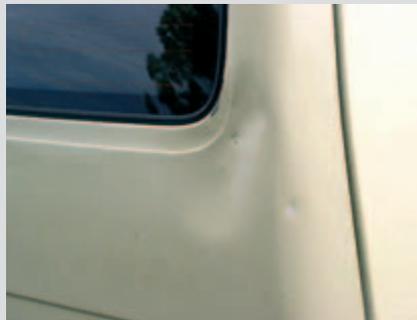
... regardless of whether or not the paint layer has been penetrated.

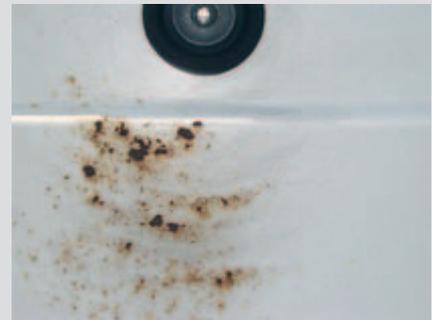
Damage which has corroded.

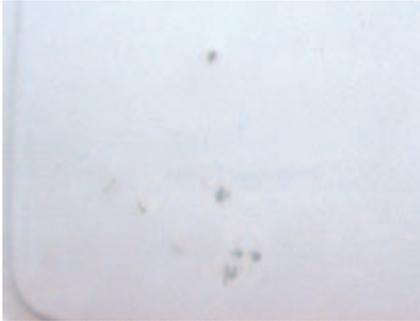
Here we see an example of acceptable, light damage which has not penetrated the paint through to the base coat.

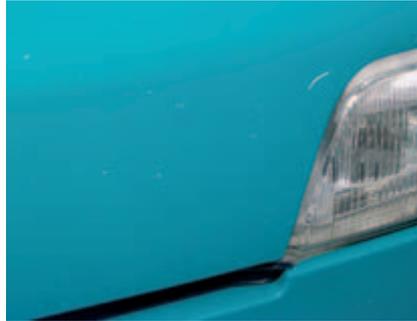
Scuffing or scratches with a maximum length of 10 cm.

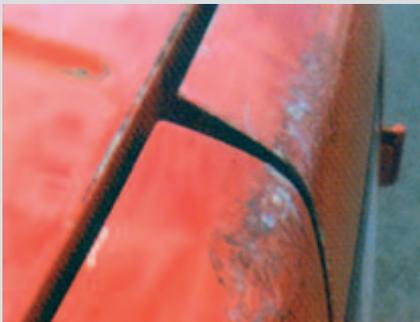
Excessive scratches or paint damage that may have arisen from activities other than proper loading.

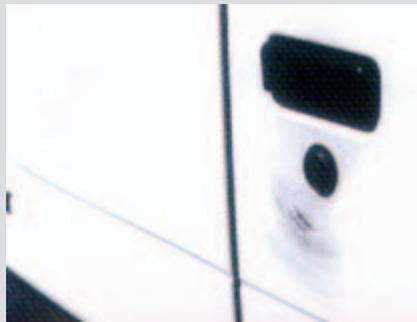
Here we see an example of excessive scuffing which is apparent, as there is more than one scuff area on the panel.

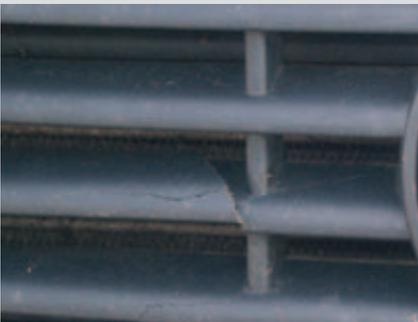
Broken grilles.

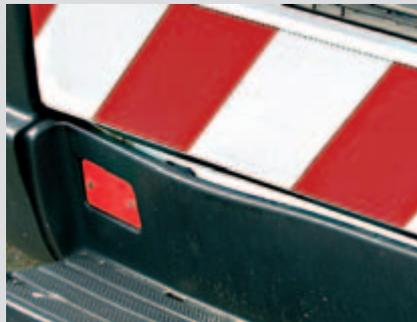
Deformed or missing parts.

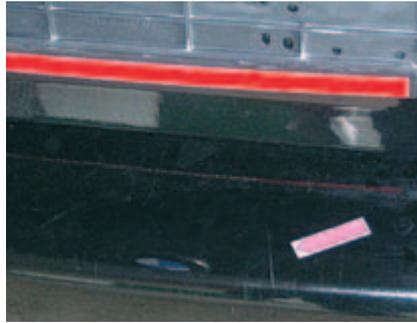
... provided there is a maximum of two areas of damage per bumper.

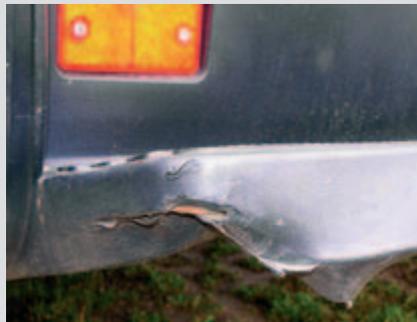
Broken, deformed or severely damaged bumpers are not acceptable. Please ensure tow bars are returned with covers and detachable trailer couplings.

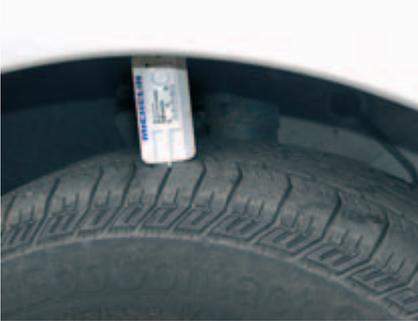
Tyres with a minimum tread of 2mm. Please note that all tyres, including the spare, must be in legal condition and conform to the manufacturer's recommendations regarding tyre size & type.

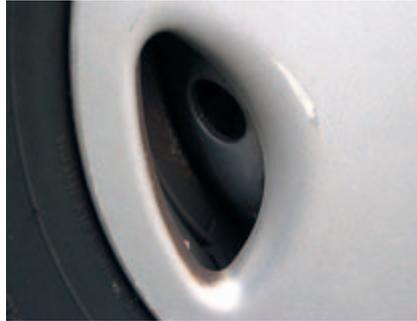
Light scuffs or scratches on wheel trims.

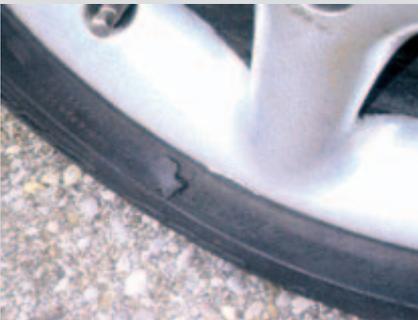
Tyres with damage caused by "kerbing" or other abuse. Bald tyres are unacceptable.

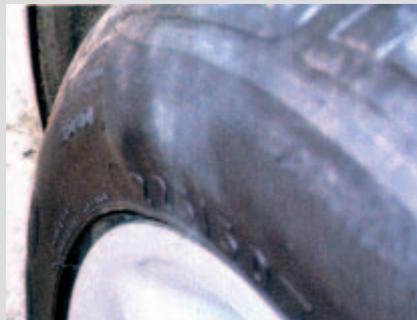
Bulges, cracks or cuts to the tyre or excess damage to the sidewall or tread.

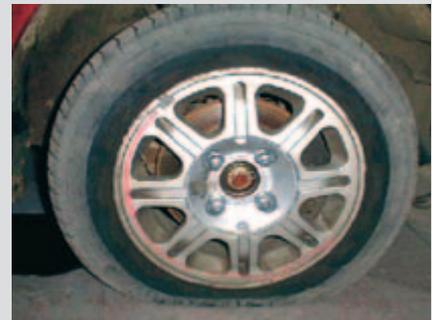
Flat tyres due to damage or penetration of a foreign object, and affecting the safety of the vehicle.

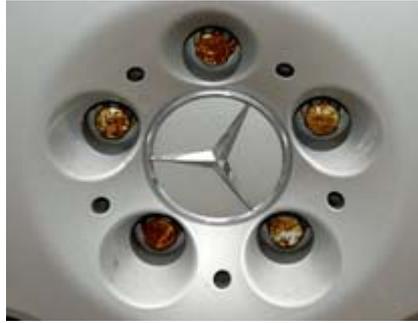
Wheel nuts that are rust and deformation free.

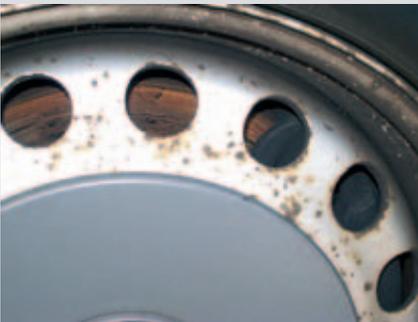
Deformation of the bead of the rim, missing material or rust.

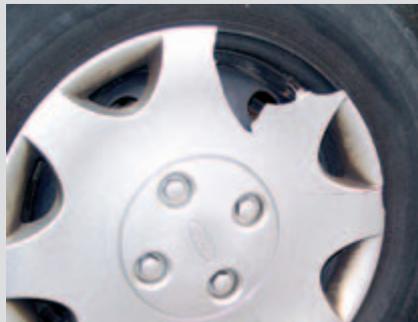
Breaks or missing material on wheel caps. Scuffing and scratches causing a deformation of the wheel cap.

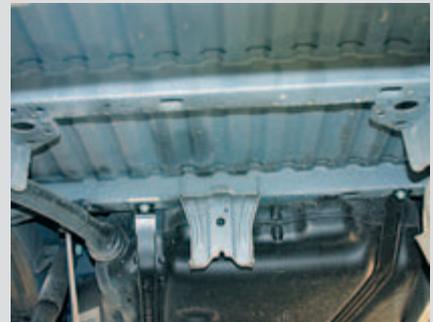
Missing spare wheel, if it is included as basic equipment, or a missing or only incomplete "Tyre Mobility Set."

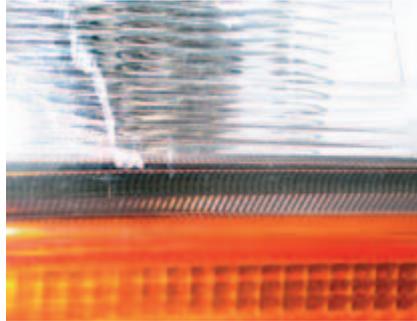
Here we see a small crack in the lighting unit which is acceptable as it does not impair the use of the unit.

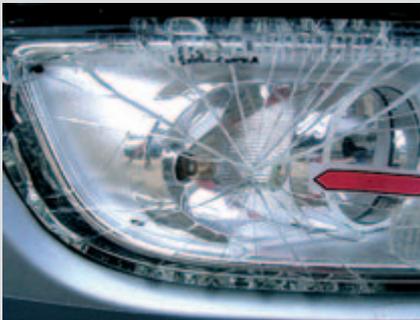
Chippings in the headlights, fog lights or indicators having broken the glass or the transparent covers.

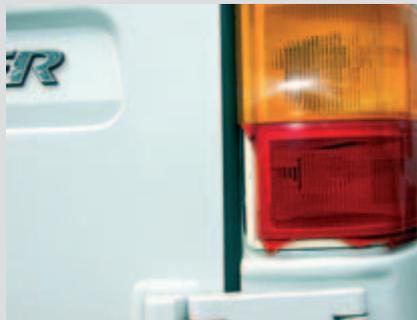
As before: The damages show as a tear or a hole and influence the technical function.

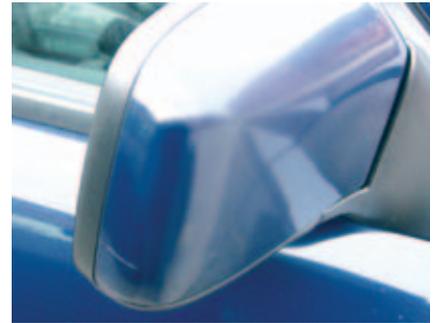
For painted mirror casings only scuffing and scratches with a maximum length of 5 cm which have not penetrated the base material. The function must not be affected.

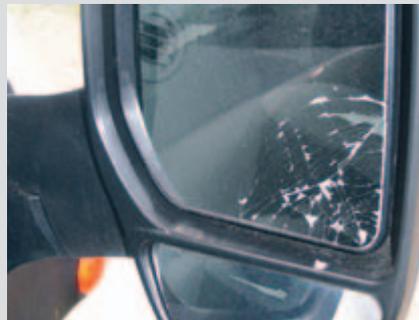
Glass should be intact. This picture clearly shows cracked glass. Deformed mirrors are also unacceptable if the function of the mirror is compromised.

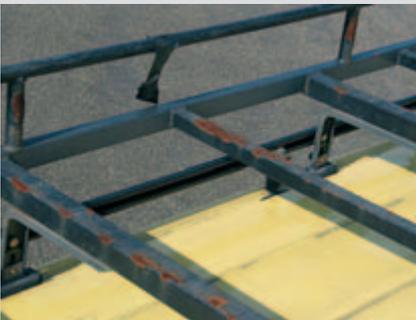
Fitted roof racks must not be broken, rusted or damaged in any way that would affect safety.

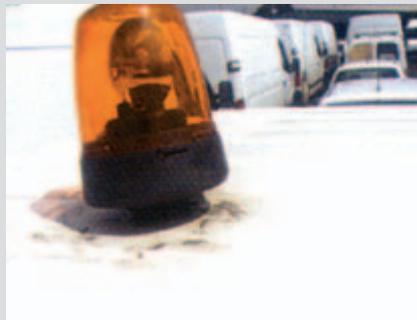
Shown here is a beacon which has not been correctly fitted. Badly fitted beacons or lights with breaks are not acceptable. These do not comply with road safety.

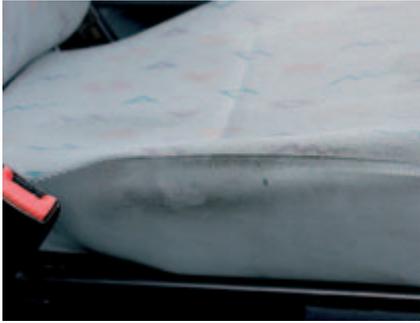
Wear and tear through general usage.

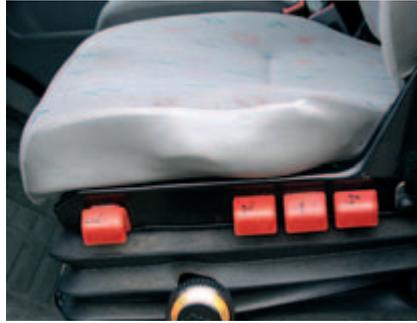
Again an example of acceptable wear.

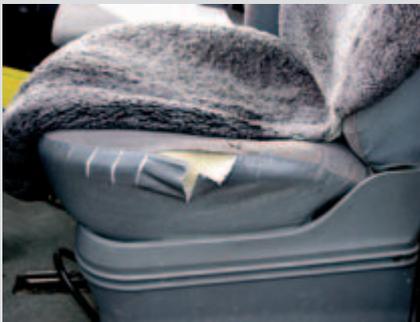
The seats covers are torn or material is missing from the upholstery.

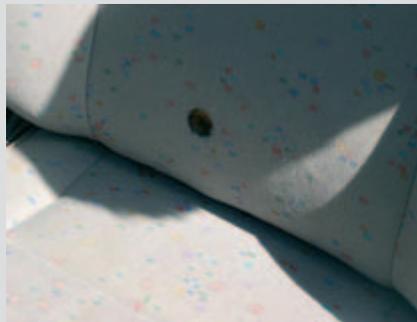
Holes/cigarette burns or tears in the upholstery.

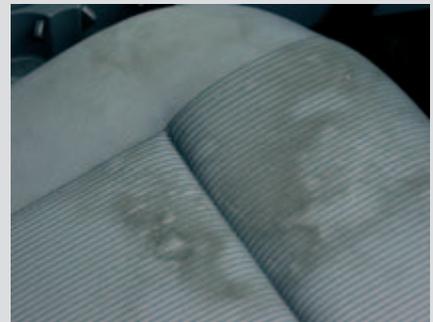
Heavy stains on the seat that cannot be removed by normal cleaning.

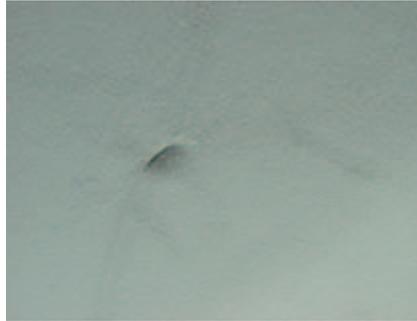
Minor damage, as shown above, to the headlining is acceptable.

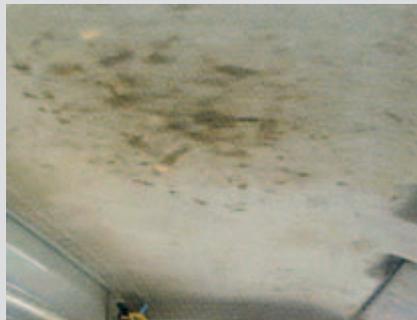
Here we are shown an example of unacceptable staining, which is excessive and cannot be removed by normal cleaning.

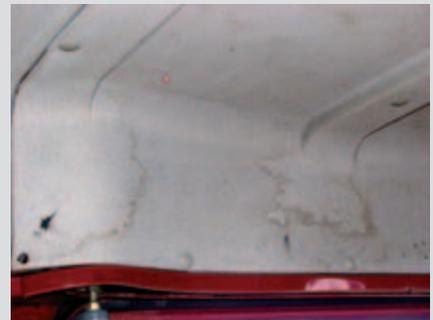
Panel headlining which is heavily deformed, torn or has cuts in the material is not acceptable.

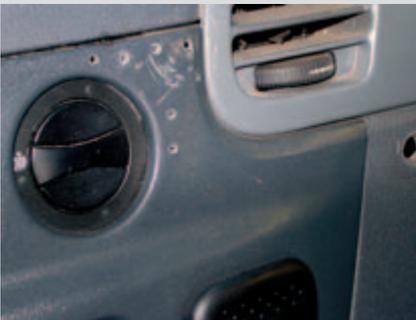
Clearly visible holes in the centre console. These should be repaired professionally.

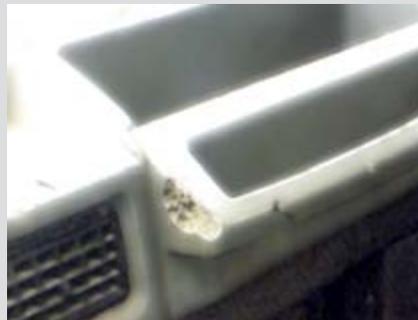
The dashboard is clearly damaged – torn, ripped or deformation of the dashboard is not acceptable.

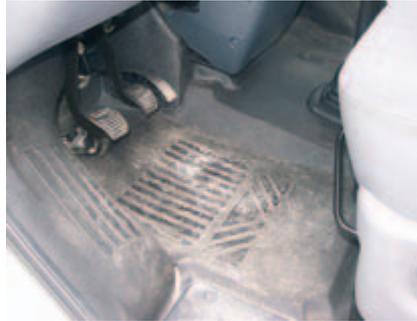
The foot well area shows signs of wear due to day to day usage.

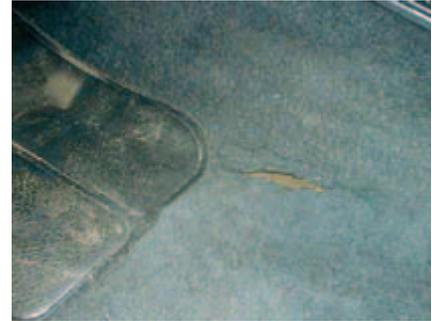
Abrasions, light staining & minor tears are acceptable in the most used areas of the carpet.
